# Capacity Evaluation and Spectral Analysis of Damaged Low-Rise Reinforced Concrete Building

<sup>1</sup> Polytechnic University of Tirana, Faculty of Civil Engineering, Tirana, Albania

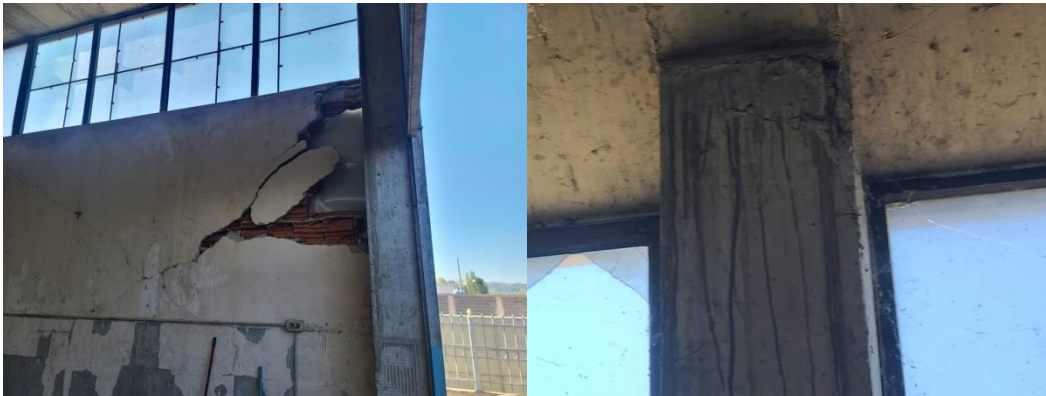
Based on observations, it was revealed that the three-story building in Fushë Krujë has incurred light to moderate damages in its load-bearing elements, mainly in some columns of the first-floor skeleton. In general, the columns have suffered minor damages, but their dimensions and the reinforcement placed in them are assessed as insufficient. They measure 60x40cm and are reinforced with 8 $\phi$ 18. Given that the lower floor has a considerable height, the soft-story phenomenon occurs, contributing to the majority of damages on the ground floor. The building can be considered a structure with a load-bearing skeleton, as mentioned earlier, since the columns have a load-bearing effect, while the non-bearing walls do not affect the load-bearing capacity of the building. The perimeter walls, on the other hand, are quite damaged but deemed repairable. They lack seismic bands, and due to the uneven deformation of the skeleton and masonry, various cracks have occurred.

**Figure 5.** Wall and column damage on the first floor of the structure

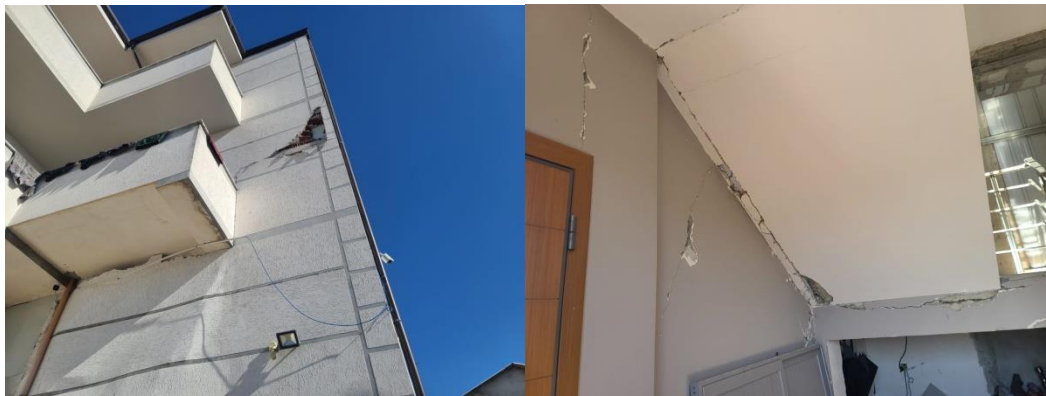
In the masonry, cracks have been observed in various sections, along with the detachment and separation of non-load-bearing elements from the rest of the structure. High moisture content has been noted in the structure, leading to material degradation in various parts, such as walls and foundations. The material quality is poor, and fractures from shearing forces have been observed in the perimeter walls; however, damages to the walls are predominantly repairable.

**Figure 6.** Damage on perimeteral walls of the façade

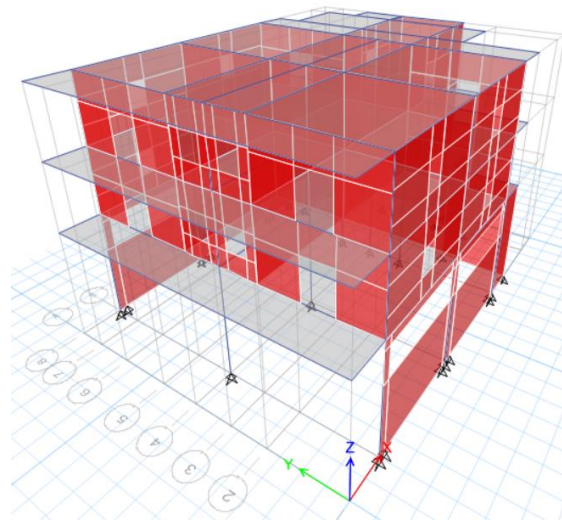
**Figure 9.** Mathematical model of the structure (using etabs software)

Given that the building has the first floor with a significantly greater height of 5.45m compared to the other two floors, which are 3.3m each, and considering that the column dimensions of 60 x 40 cm do not provide sufficient stiffness, the phenomenon of soft story is observed. Below is the computer model of the existing structure built using the ETABS 2018 program.

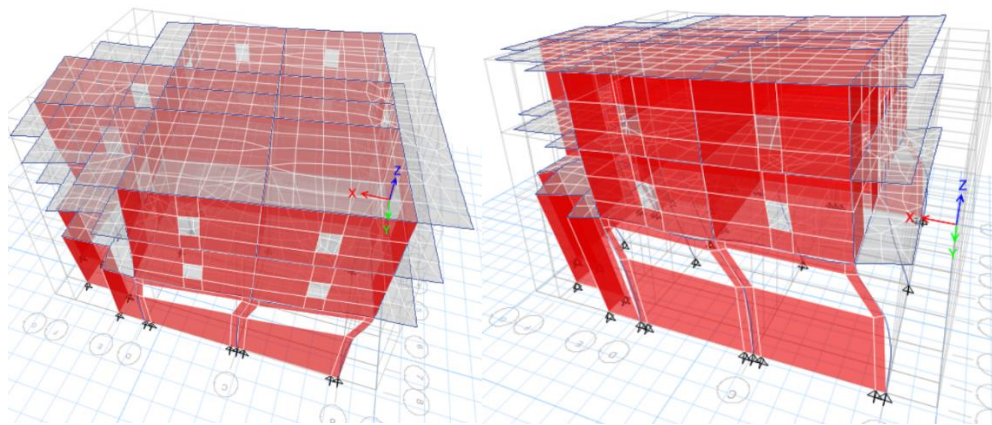
The model has undergone an initial modal analysis. It is observed that the first and second modes of vibration exhibit significant torsional effects. This is attributed to the fact that the columns of the structure have very disproportionate dimensions (60cm x 40cm), and the soft story experiences torsion due to the lack of proper stiffness in the supporting frame. Considerable effects are also contributed by the cantilevers and appendages in the east direction of the structure, which have a relatively significant length. The period of vibrations is also significantly lower than the recommendations of EC-8 for reinforced concrete frame structures. The expected period for masonry-bearing structures according to  $T=0.1 \cdot n_{\text{floors}}$  to EC-8 is calculated based on the formula above.

**Figure 10.** First two modes of the structure exhibit significant torsional effects

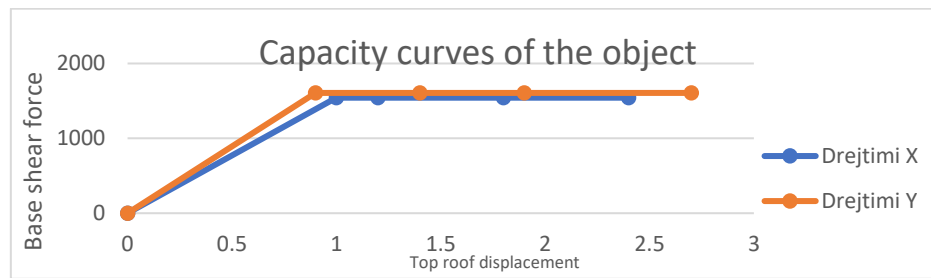
Direction	Shear force	Weight of structure	Disapl. DL	Displ. SD	Disapl. NC	Disapl. ult
X	1543 kN	3784 kN	1 cm	1.2 cm	1.8 cm	2.4 cm
Y	1607 kN	3784 kN	0.9 cm	1.4 cm	1.9 cm	2.7 cm

Figure 11. Capacity curves of building in x and y directions

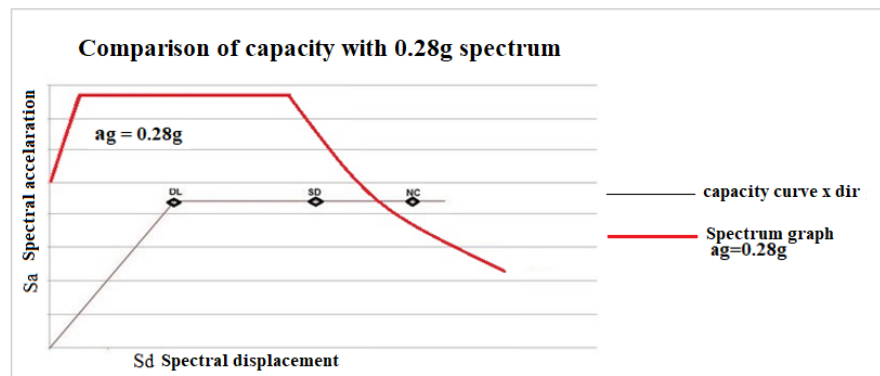
Following this analysis, a comparison was conducted between the structural capacity and the earthquake design spectrum for 0.28g, as detailed in the previous chapter. The evaluation is then made through a comparison in the spectral acceleration - spectral displacement (Sa-Sd) format. The comparison graph below illustrates that the structure has surpassed the SD performance level and is now in the NC phase. According to EC-8, this implies significant structural damage, necessitating structural reconstruction. For this seismic level, with a return period of 1/475 years for the zone, the structure should not have reached the SD level, let alone transitioned into the NC phase.

Figure 12. Comparison of capacity versus spectrum

From the seismic analysis for the existing structure for an earthquake with a ground acceleration level of 0.28g, corresponding to a return period of 475 years for the area, the structure is designed to the performance level NC Near Collapse or near-collapse phase. According to EC-8, for this level of seismic activity, the structure should not exceed the performance level SD. This implies that the building needs reinforcement to increase its structural capacity and performance.

Three main interventions are proposed by the authors for the reinforcement of the existing structure:

- Installation of Reinforced Concrete Columns: Concrete columns will be planted to form a moment-resisting frame system for the structure.

- Placement of Reinforced Concrete Shear Walls: Concrete shear walls will be positioned along the perimeter of the building to enhance its lateral resistance.
- Strengthening of Foundations: Foundations will be reinforced to provide a robust connection and to increase their load-bearing capacity.
