# Capacity Evaluation and Spectral Analysis of Damaged Low-Rise Reinforced Concrete Building

<sup>1</sup> Polytechnic University of Tirana, Faculty of Civil Engineering, Tirana, Albania

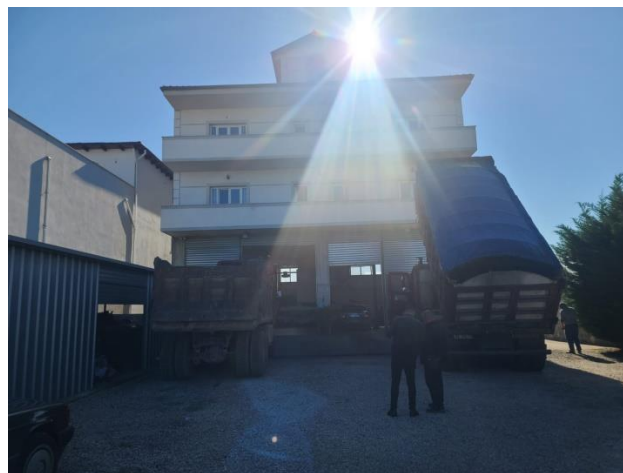
**Figure 4.** Facade view of the building

In the perimeter walls, considerable damage has been observed; however, given that they primarily have a non-load-bearing effect, the damages are repairable. The relatively tall height, especially of the first floor, has resulted in structural damages, but these are also repairable. Lightweight aggregate concrete, characteristic of skeleton structures, has been used for the masonry. For similar constructions in this area, low-grade cement, with a strength rating of 2.5 MPa, has been utilized. The beams and columns are made of low-grade concrete (C20/25) with non-negligible steel reinforcement. Additionally, the protective layer of concrete covering the steel reinforcement is less than 4 cm, and, as evident in the photos below, in some areas, this layer has been damaged. According to information obtained from residents, the foundations are of the isolated type under each column, with a relatively shallow depth of about 80 cm.

- Placement of Reinforced Concrete Shear Walls: Concrete shear walls will be positioned along the perimeter of the building to enhance its lateral resistance.
- Strengthening of Foundations: Foundations will be reinforced to provide a robust connection and to increase their load-bearing capacity.
