Energy Efficiency Analysis in Korça Regional Hospital

Altin Dorri^{*1}, Klodian Dhoska¹, Saidjon Kodhelaj²

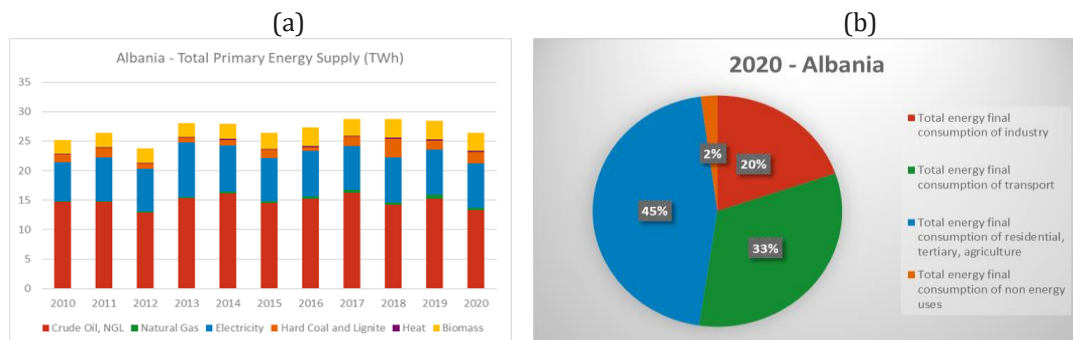
Figure 1. a) Primary energy sources in Albania, b) Final energy consumption by sector [1].

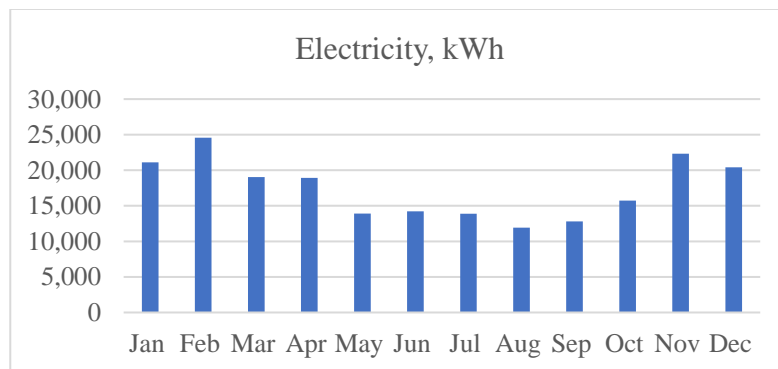
Monthly data on electricity consumption for the year 2021 are shown in Figure 3. Compared to previous years hospital had a slight increase in electricity consumption, which is a good indicator. While in Figure 4 is given monthly fuel/pellets/thermal energy consumption. Also, regarding thermal energy consumption, we have a slight increase compared to previous years.

Figure 3. Monthly electricity consumption

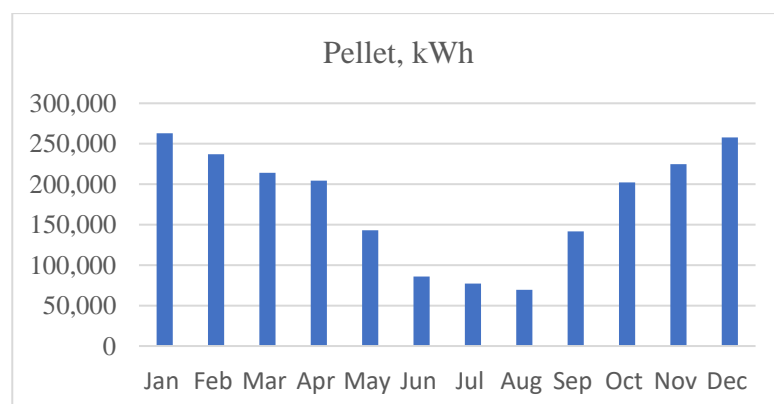
Figure 4. Monthly thermal energy consumption

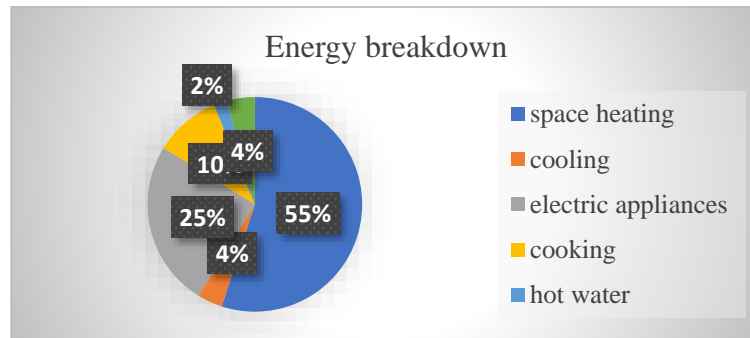
Figure 5 below shows the breakdown of energy by all covered services. We can see that space heating and cooling is the largest energy consumer, followed by electrical appliances. Cooking and lighting are also significant energy consumers. This is understandable, as Korça is located in the climate zone C (the coldest climate zone in Albania). This is also evident from the fact that the majority of energy consumption is thermal (pellet or LPG).

Figure 5. Energy breakdown for each service

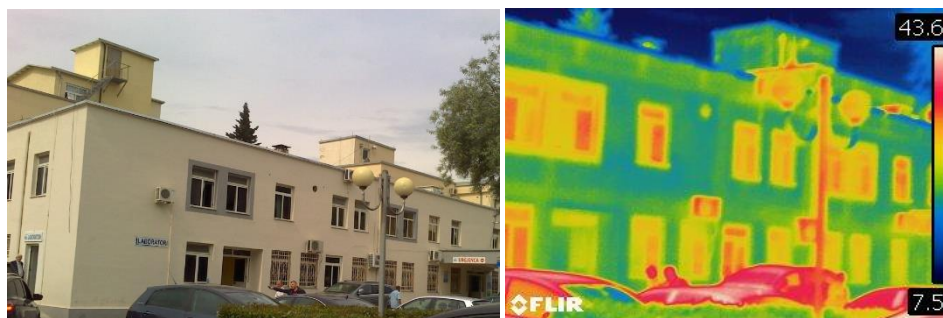
This analysis also revealed insufficient thermal insulation for the buildings, as most of the heat loss comes from the walls. For this, the image from the thermal camera can help us to have a clear idea (see Figure 6).

Figure 6. Image of façades from thermal camera

The highest energy savings potential is identified by investments in energy savings for space heating through thermal insulation of the external walls, thermal insulation of the roof, efficient windows and the introduction of an efficient diesel heating system. Financial analysis will help us to have a good idea of which energy efficiency measures are the most feasible and

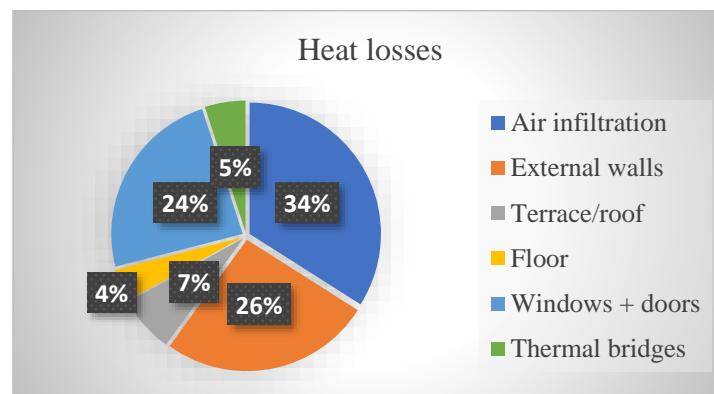
Our analysis of heat loss showed that the majority of heat loss was through infiltration and then through walls and roofs. Figure 7 below illustrates the heat losses across each component of the building.

Figure 7. Individual building element heat losses
